# Manhole Inspection Summary

Manhole # S35GG\_020MH

Insp Date: **3/14/07 12:10 PM**

**Location** Address: **1500 OLIVER ST**

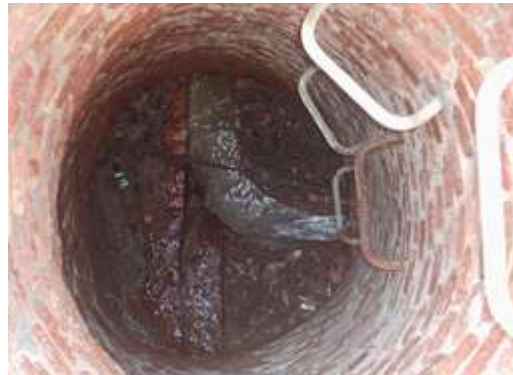
Top View

Corroded steps. Evidence of surcharge -  
Bench debris

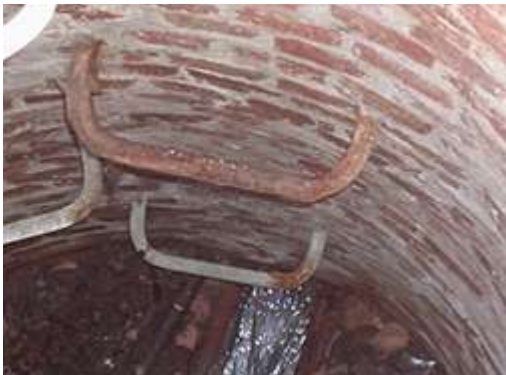
Defect

Corroded steps.

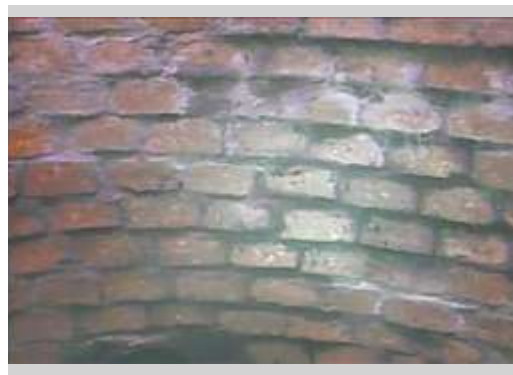
Defect

Barrel infiltration.

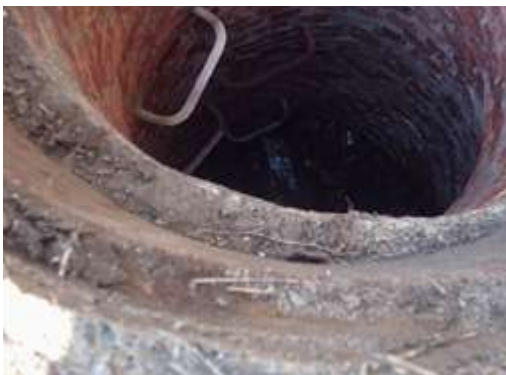
Defect

Frame offset. Adjustment infiltration.

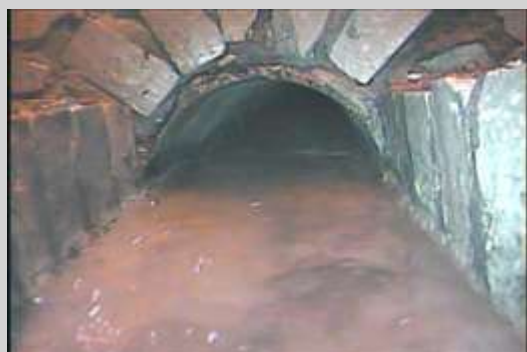
Pipe Out @ 12 O'Clock

Invert Depth: **9.15** (ft.) Flow Characteristics: **Slow**

Infiltration: **Evidence** Pipe Seal Cond: **Unknown**

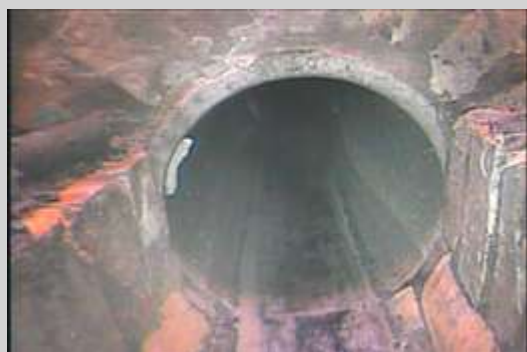
Pipe In @ 3 O'Clock

Invert Depth: **8.89** (ft.) Flow Characteristics: **Fast**

Infiltration: **None** Pipe Seal Cond: **Unknown**

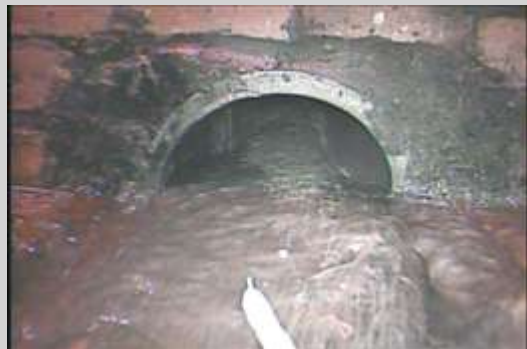
Pipe In @ 6 O'Clock

Deposits: ☐ None ☐ Mud ☐ Sludge ☒ **Debris** ☐ Grease

Silt Depth: **3** (in.) Deposits Extent: **Heavy**
